## (CONDITION)

## VACUUM EXCAVATION REPORT

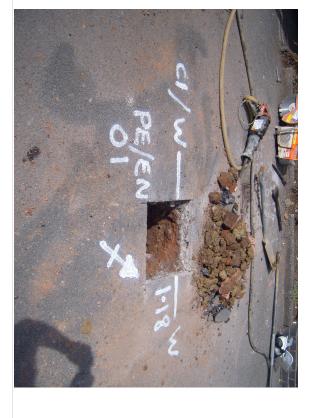
VACUUM EXCAVATION LOCATION

Approximate 6" Cast Iron water pipe in good condition.
